PHASE I MILESTONE INSPECTION REPORT

Heather Ridge West III Association, Inc.

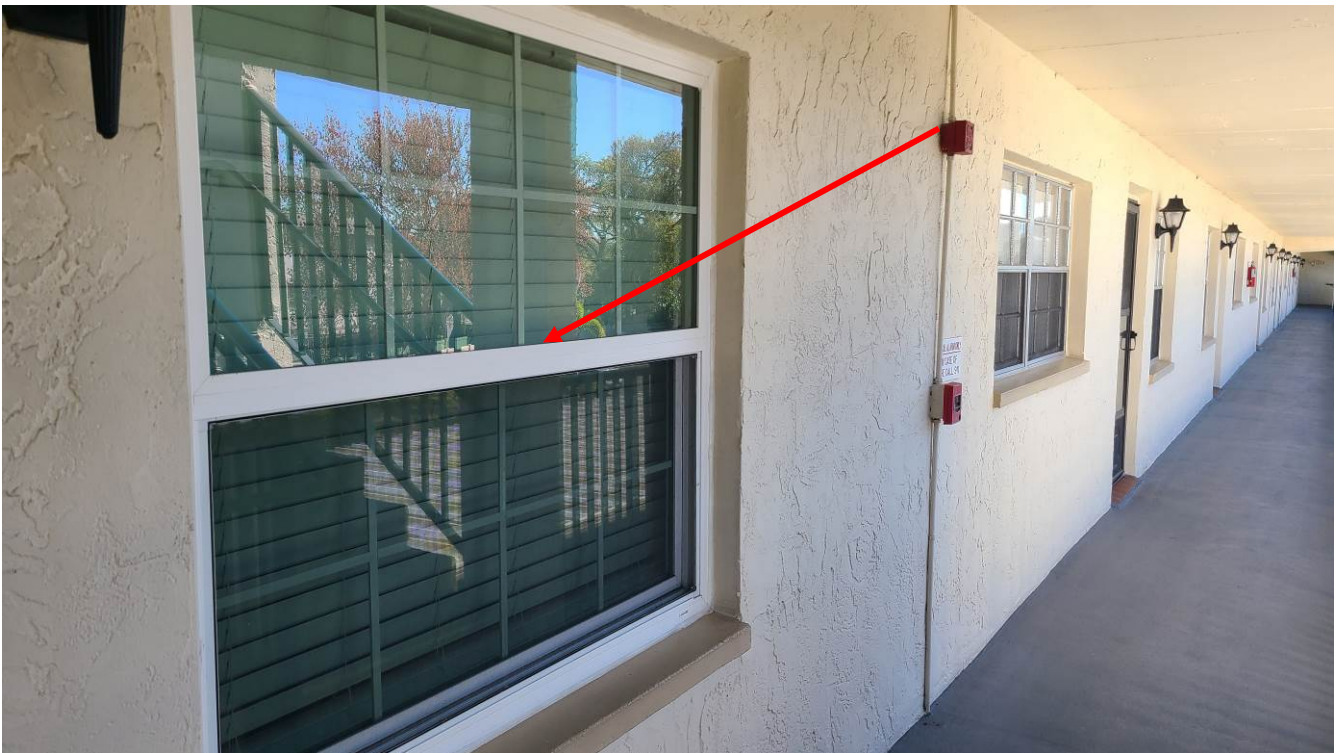
Photograph 10: Unit Windows – Appear Replaced

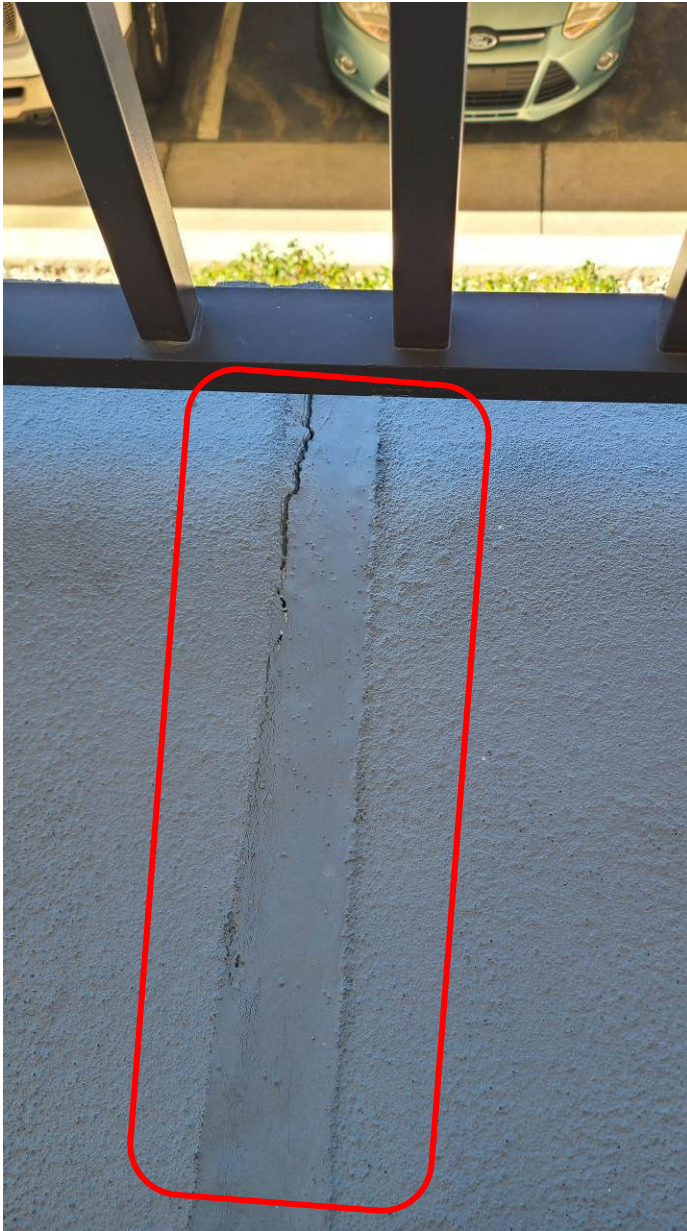
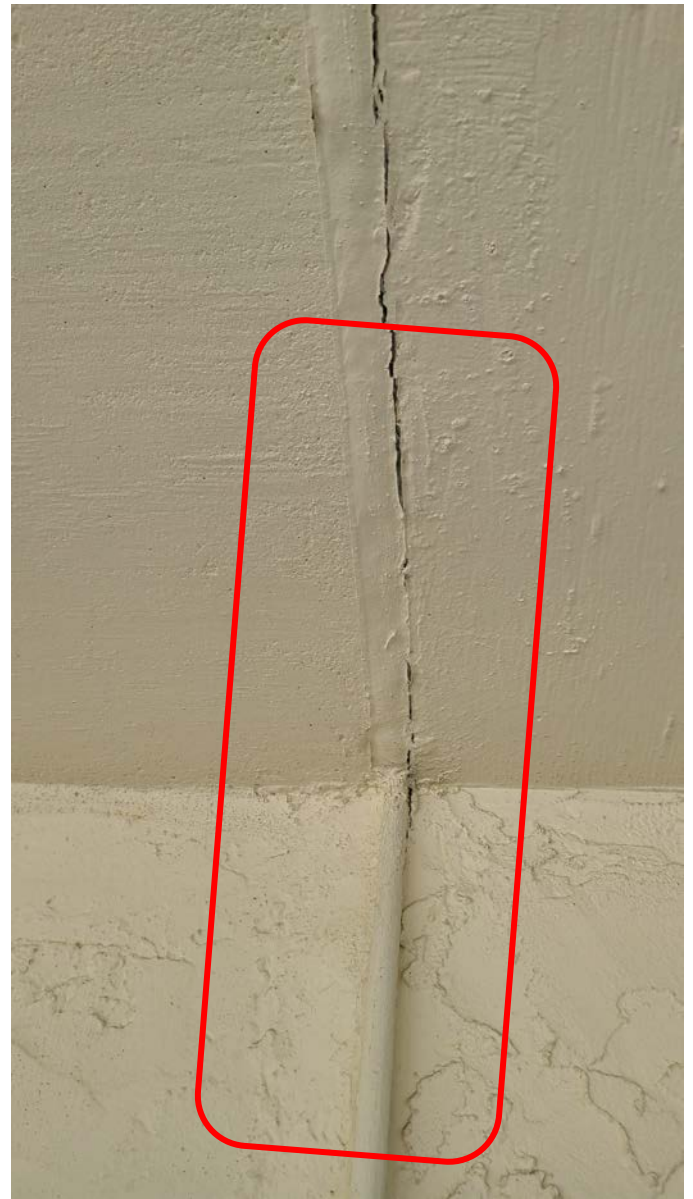
Photograph 12: Improper Detail at the Expansion Joint, 2nd and 3rd Level Walkway. Recommend Installing Approved Material Suitable for Expansion Joint Detail

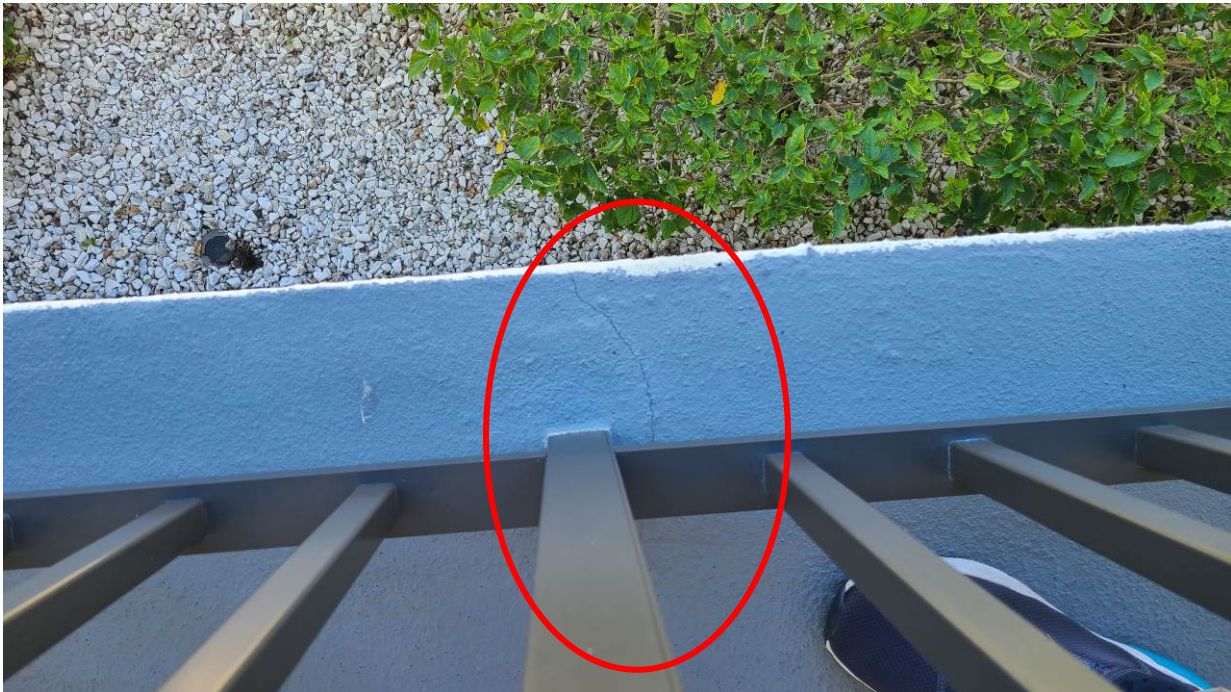
Photograph 14: Cracked Deck Coating near Unit 206

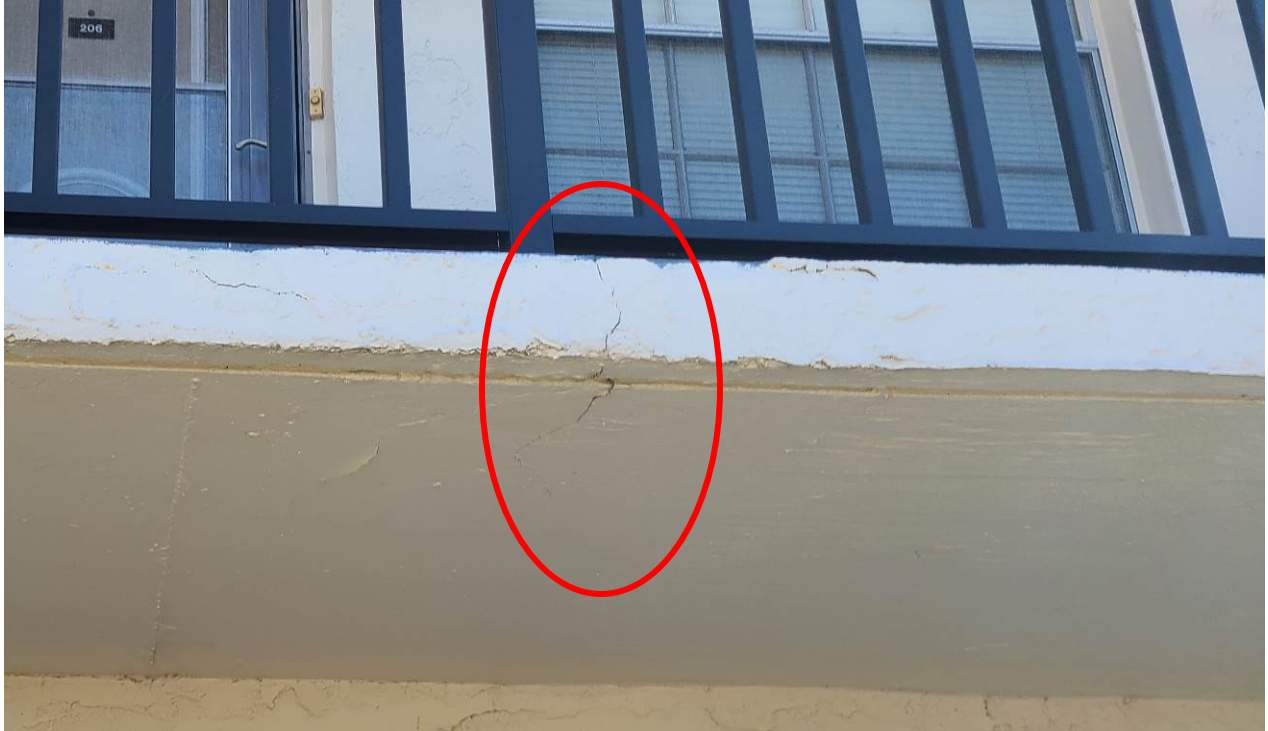
Photograph 15: Spalled Walkway Edge near Unit #206

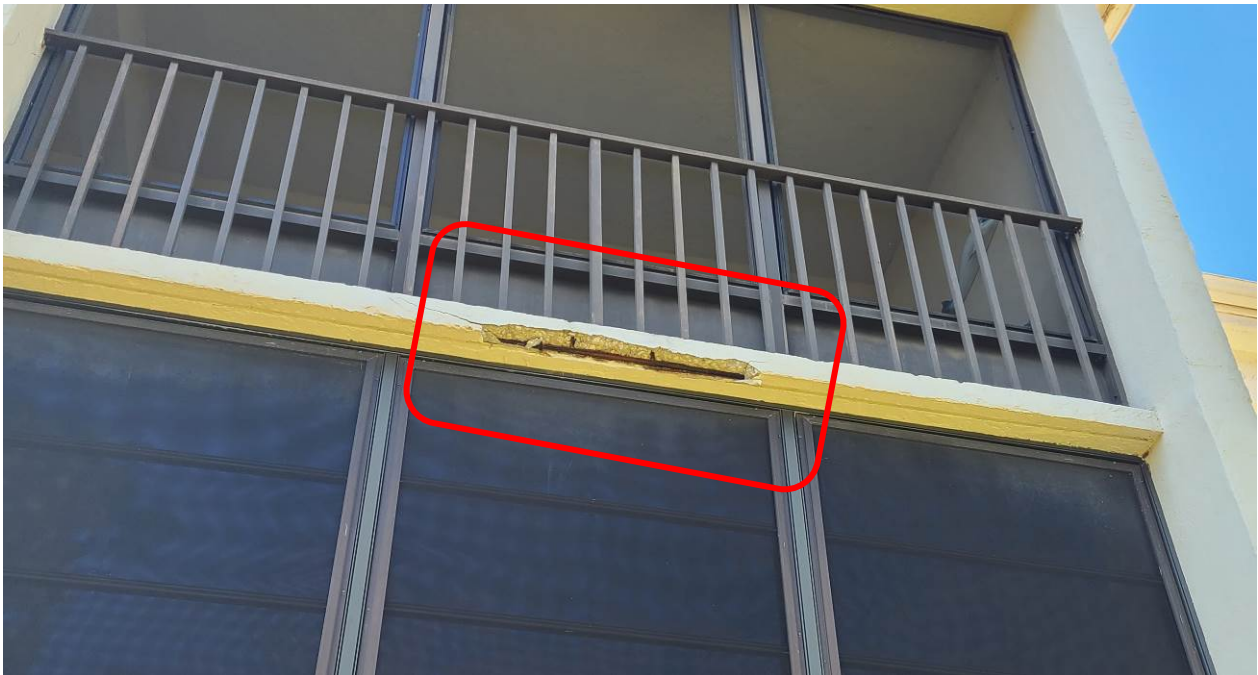
Photograph 16: Spalled Balcony Edge at Unit #308
