January 6, 2025

Re: Heather Ridge West III Condominium Association, Inc.

Structural Integrity Reserve Study (SIRS) 1375 Doolittle Lane, Dunedin, Florida 34698 UES Project No: 6011.2400193.0000

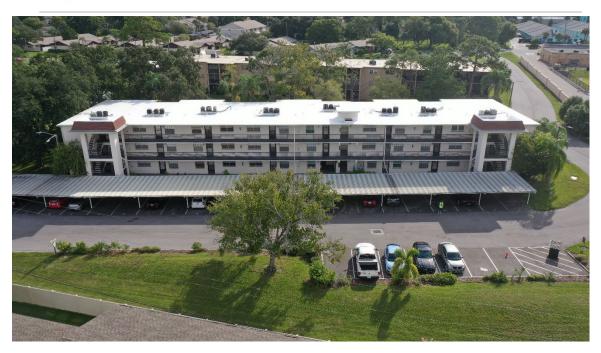
Photograph 1: View of the Front Elevation (West).

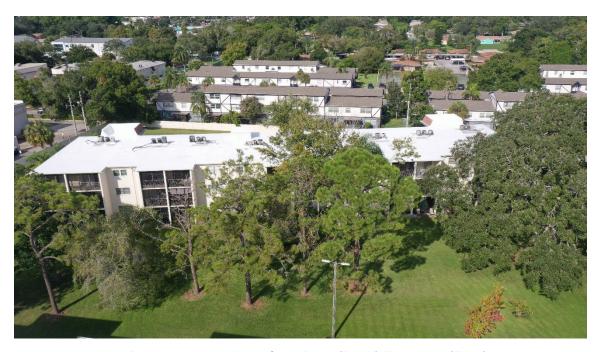
Photograph 2: View of the Rear (Back) Elevation (East).

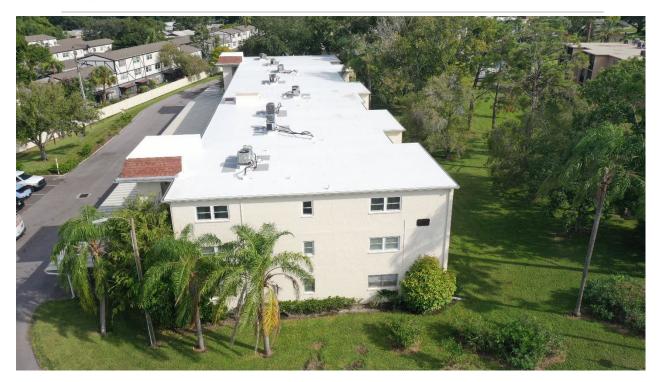
Photograph 3: View of the South Elevation of the Building.

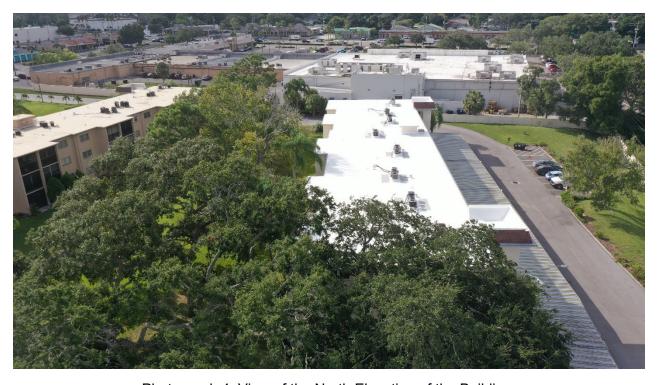
Photograph 4: View of the North Elevation of the Building.

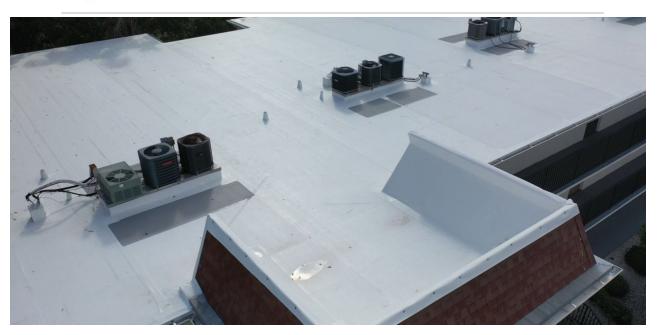
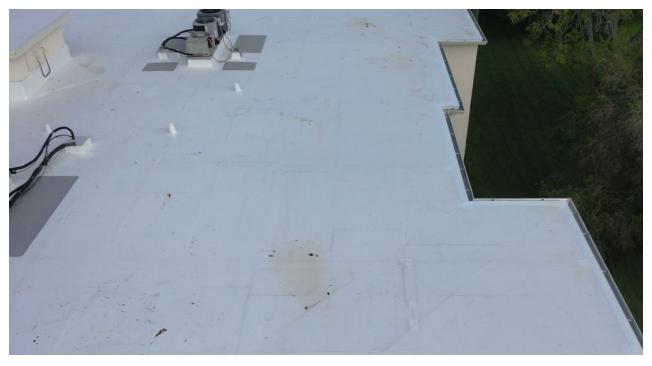
the building has flat roof covered with TPO roofing. The flat roof appears constructed of cast in please reinforced concrete deck. The existing TPO roof was replaced in August 2024, as reported. At the time of our inspection, no damage was observed to the building roofs.

Photograph 5: TPO Roof, Current Condition is Good.

A TPO roofing with proper installation, care, and maintenance has an average expected useful life (EUL) of 15 - 20 years. the existing TPO roofing is warrantied for 20-years per the provided documents. Proper maintenance includes but is not limited to visually inspecting the roof at least after a major hurricane or once a year to ensure the ply sheets are intact with no damaged or missing areas. See **Appendix A** for the estimated cost and estimated contributions required.

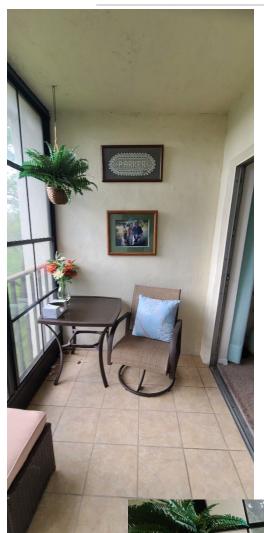
Photograph 6: Unit 303 Patio, Current Condition.

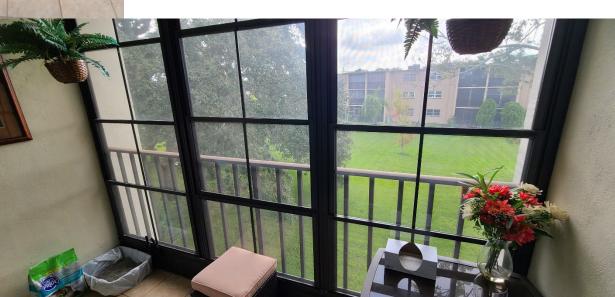
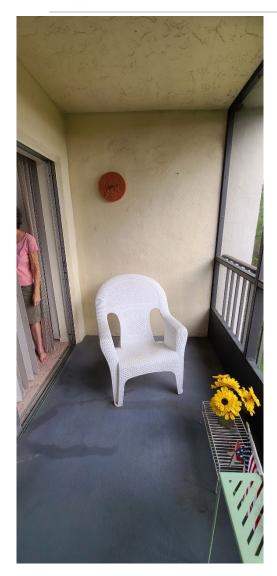
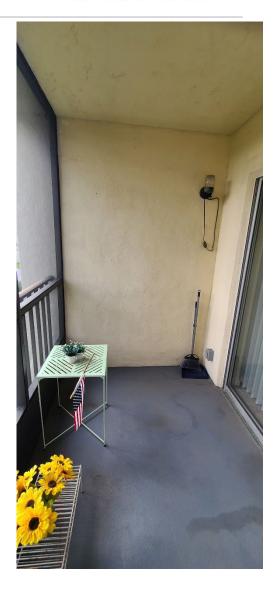
Photograph 7: Unit 306 Patio, Current Condition.

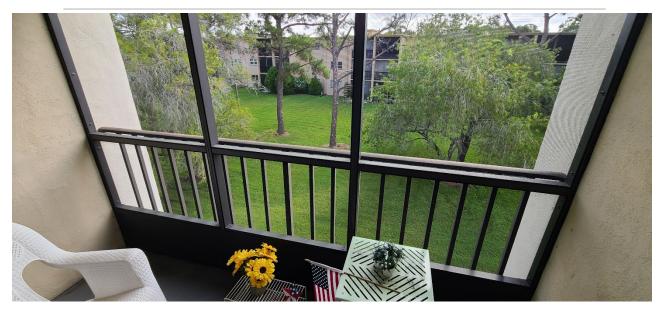
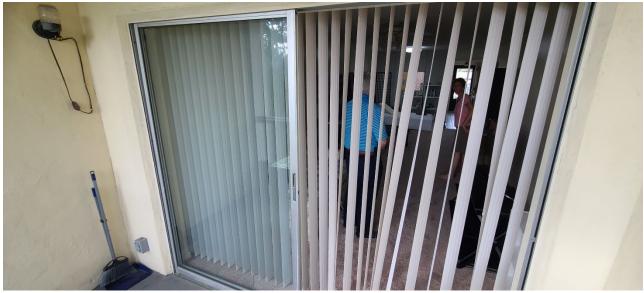
Photograph 8: Unit 306 Patio, Current Condition.

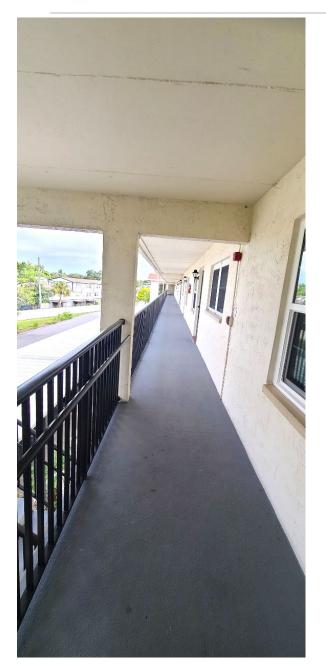
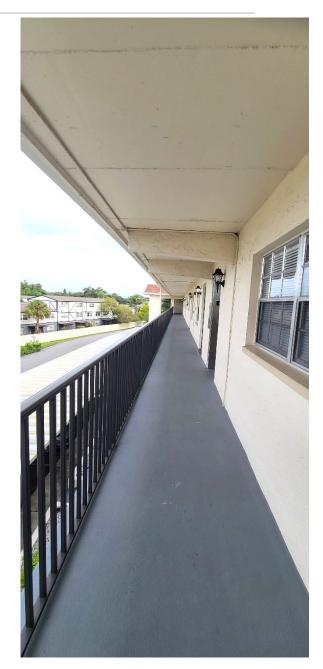
Photograph 9: Walkways, Current Condition.

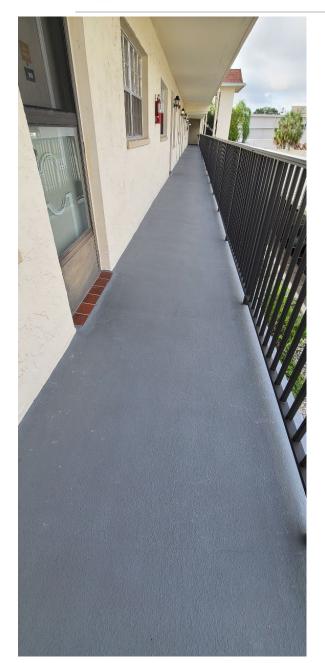
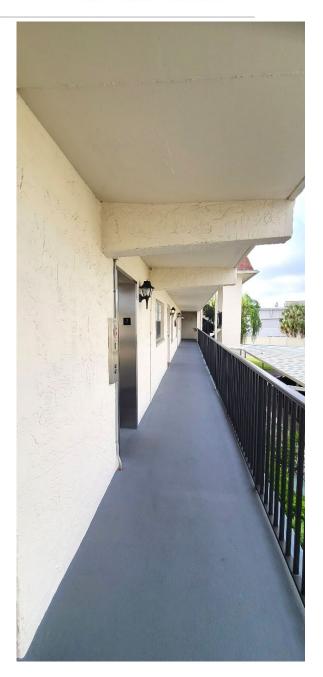
Photograph 10:Walkways, Current Condition

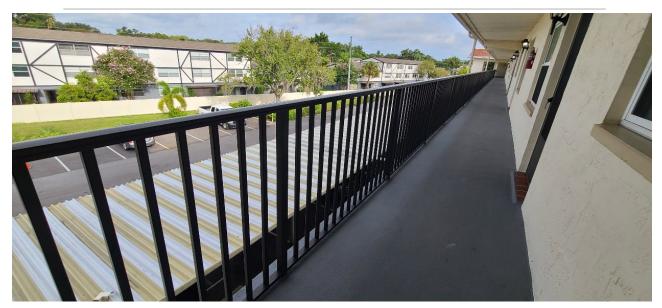
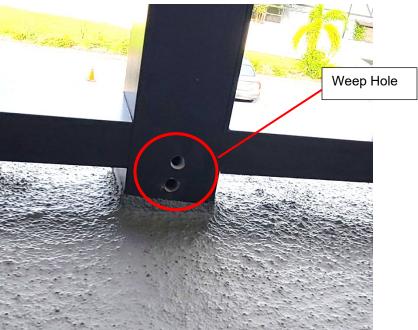
Photograph 11: Walkways Guards, Current Condition.

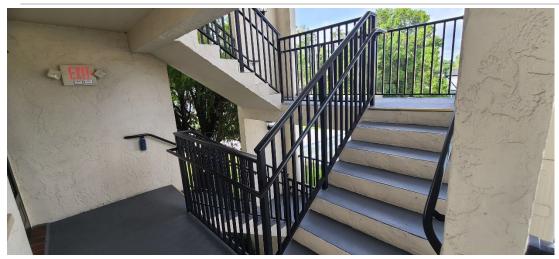
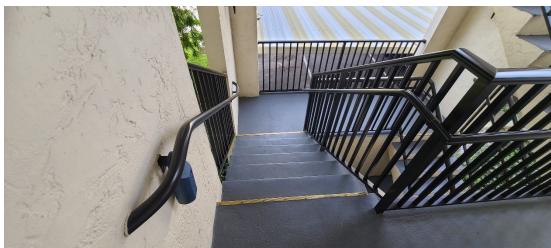
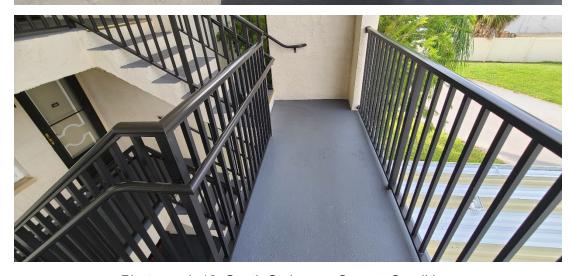
Photograph 12: South Staircase, Current Condition.

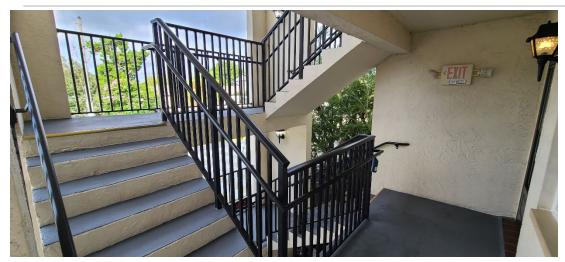
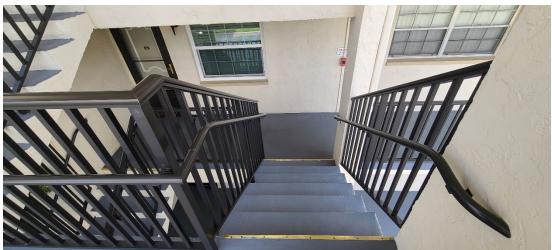
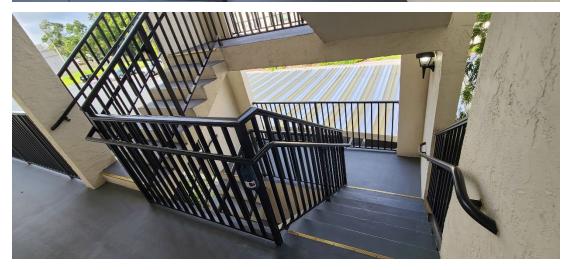
Photograph 13: North Staircase, Current Condition.

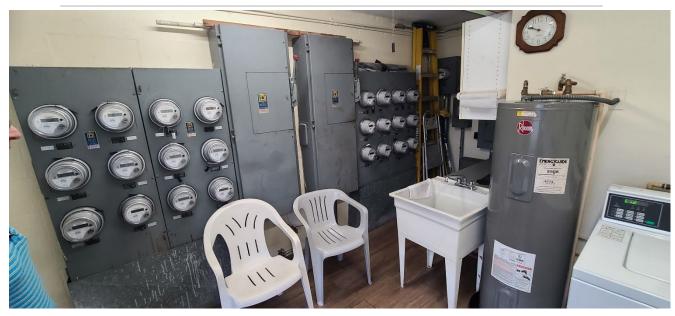
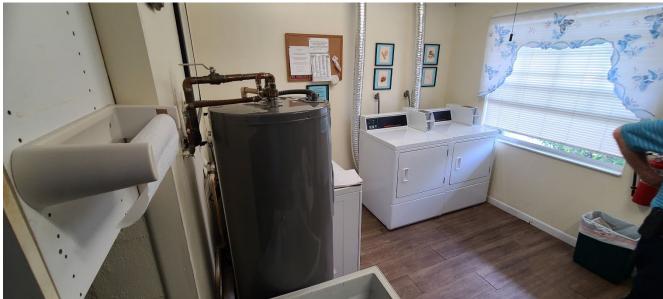
Photograph 14: Common Area, Laundry and Power Room on Ground Level, Current Condition.

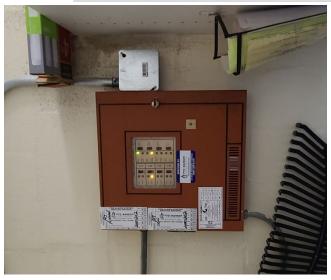
Photograph 15: Fire Control Equipment Inside Laundry/Power Room

The fire alarm system has a life expectancy of 10 to 15 years with proper maintenance. Proper maintenance includes but not limited to routine inspections by a certified technician that looks for signs of wear and tear, corrosion, and damaged parts. See **Appendix A** for estimated cost and estimated contributions required.

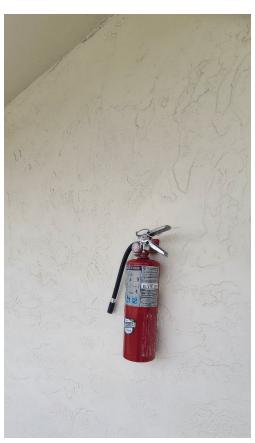
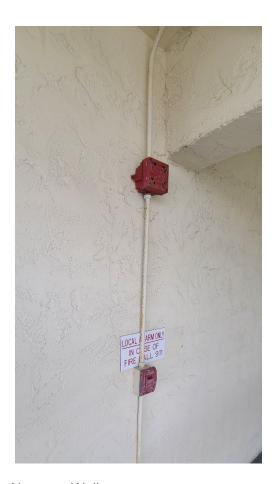
Photograph 16: Fire Extinguisher and Fire Alarm on Walkways

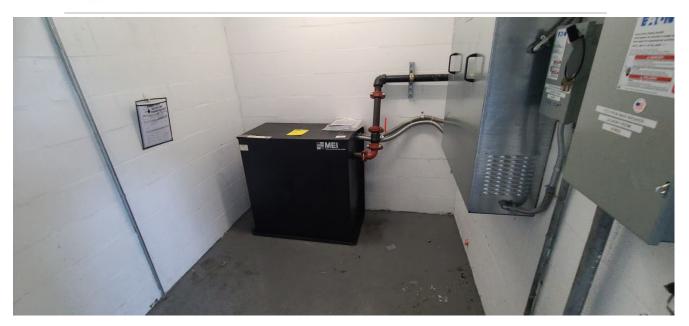
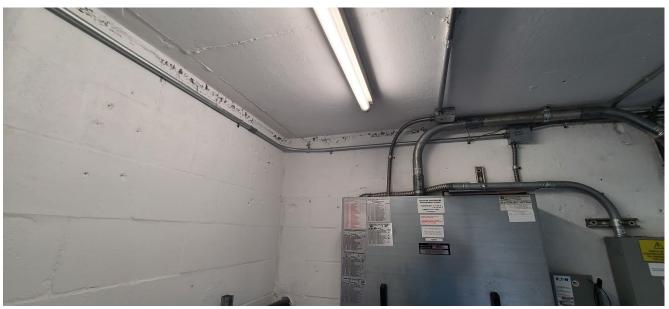
Photograph 17: Common Area, Elevator Room, Current Condition.
